Inspection Report

Minerals Regulatory Program

Mine Name: Tony M
Operator Name: U. S. Energy

Permit number: M/017/001
Inspection Date: September 13, 2005
Time: 8:30 AM to 12:30 PM

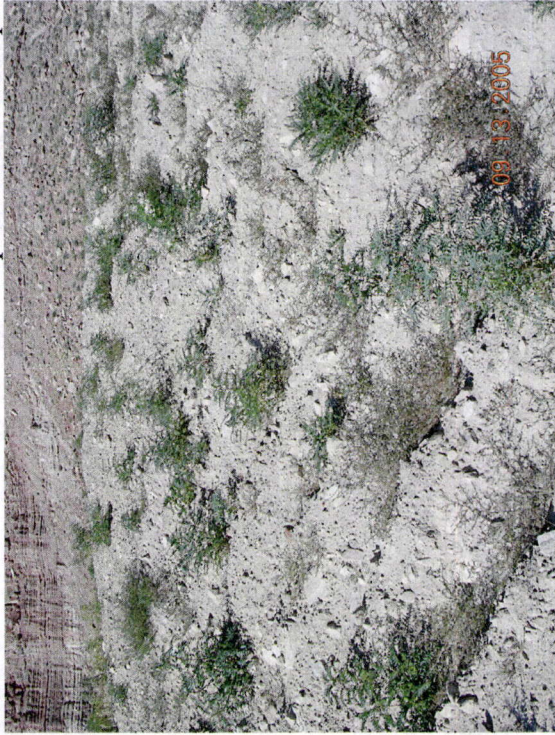
There is a lot of native volunteer vegetation growing in some areas. Locoweed (*Astragalus falcatus*) is particularly prominent (Photo 1). There are a lot of grass seedlings (Indian ricegrass) and some fourwing saltbush and shadscale. There is some Russian thistle but not too much. The biggest weed problem is probably cheatgrass in the topsoiled areas at the base of the main waste pile by the portals.

Photo 1. Volunteer locoweed. The grass seedlings are too small to see in this photo. This is one of the ore piles.

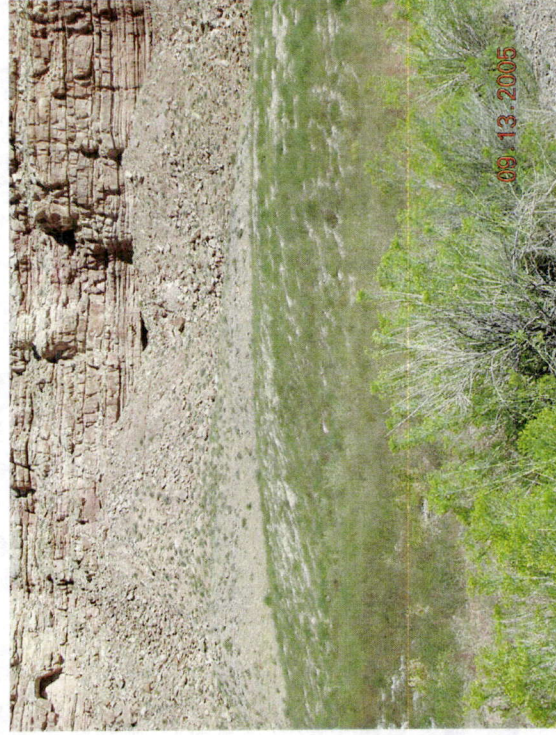
In most areas, the vegetation is progressing well. The exceptions are the channel coming from the breached dam (Photo 9), the impoundment area itself (Photo 10), and a few of the waste and low grade ore piles (Photo 2). The bottom of the impoundment is mostly clay, and since the surrounding clay hills have little vegetation, it is not surprising that there is nothing growing in this area. Likewise, much of the bottom of the outlet channel has a lot of clay, but since halogeton is growing in this area, I would expect a few other species might be able to survive.

Mr. Craft indicated U. S. Energy will probably be processing the piles of low grade ore, so, if this happens, the lack of vegetation in these areas is not a concern. Areas under these piles will need to be revegetated if the piles are processed.

Photo 2. This is a waste pile where most of the vegetation is Russian thistle.

If the operator reprocesses low grade ore, the areas under these ore piles will need to be revegetated which could prolong the time before the site can be completely released.

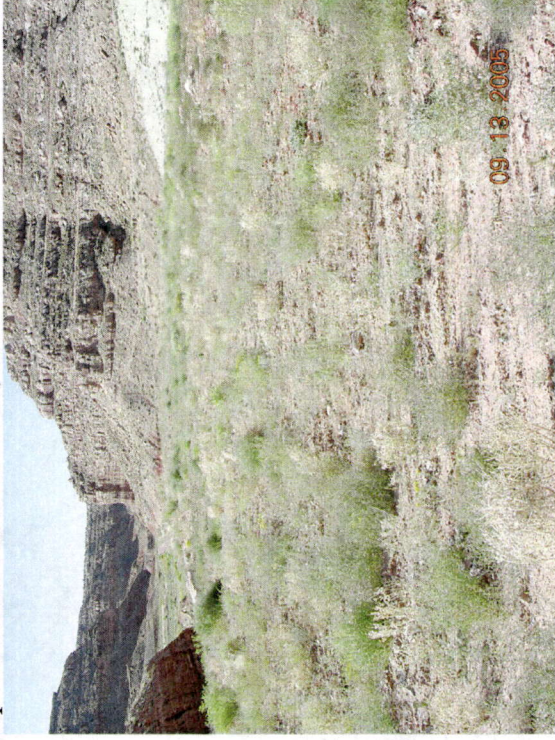
Photo 3. The topsoiled area at the base of the main waste pile. There is a lot of cheatgrass in this area, but there is also a lot of fourwing saltbush.

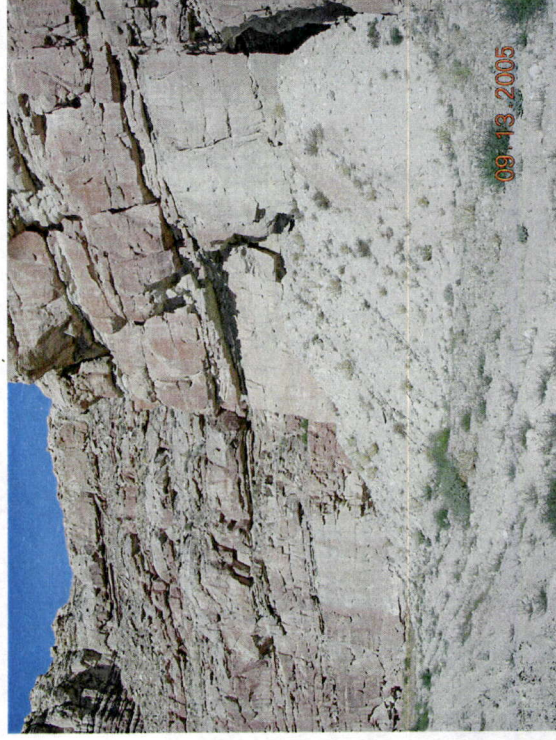
The portal area is shown in Photos 4 and 6. The material used to backfill the portals has settled a little, and although the top of the portal can be seen (Photo 6), there is no opening into the mine. The operator backfilled the openings about 50 feet back into the mine.

Photo 4. This shows the backfill material and the pad in front of the portals.

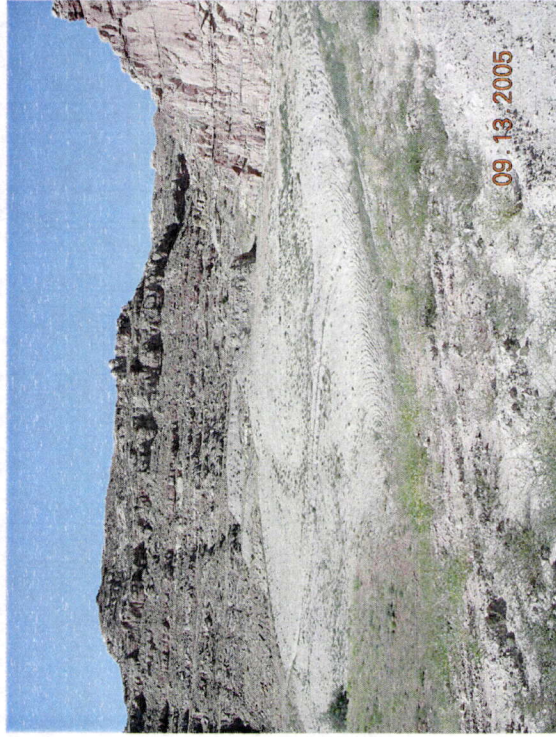
Photo 5. An overview of the main waste pile near the portals.

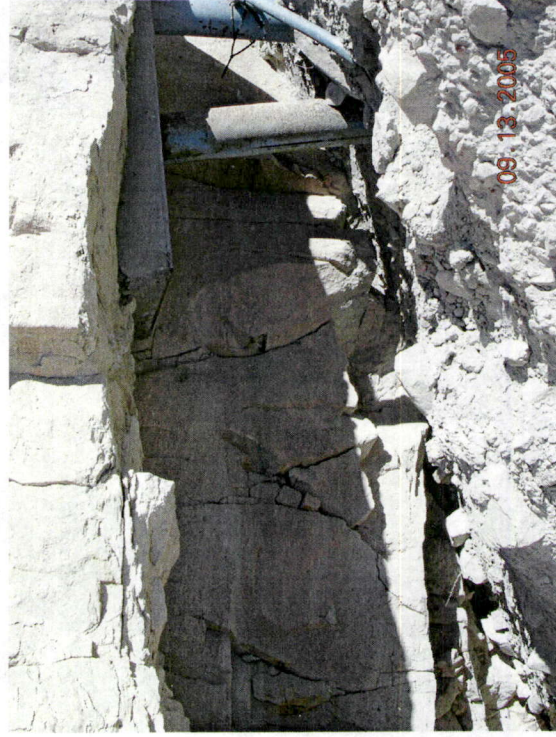
Photo 6. Looking toward one of the portals from the top of the backfill material.

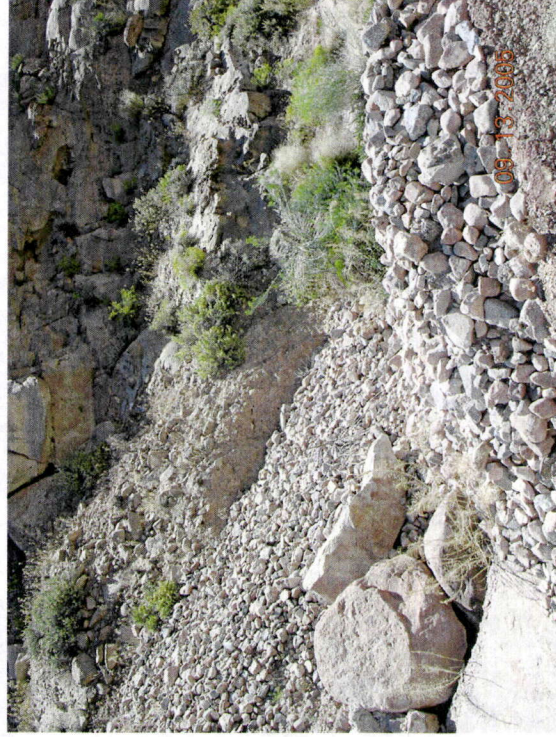
There is a drainage to the west of the portals where the operator has had some erosion problems in the past (Photo 7). According to Mr. Craft, the area had had some significant rain during the past summer, yet this channel appeared to be stable.

Photo 7. A drainage channel west of the portals.

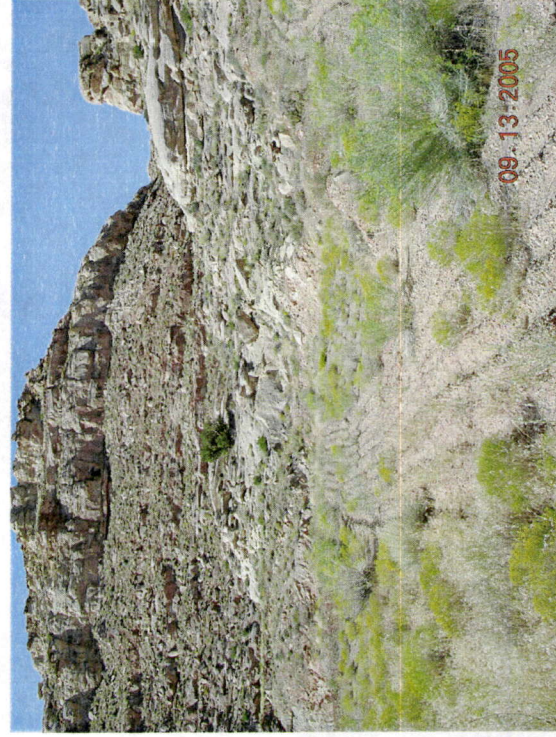
Vegetation is doing phenomenally well at the vent holes and the access roads (Photo 8). Some of these areas are indistinguishable from the surrounding undisturbed areas.

Photo 8. A vent hole access road.

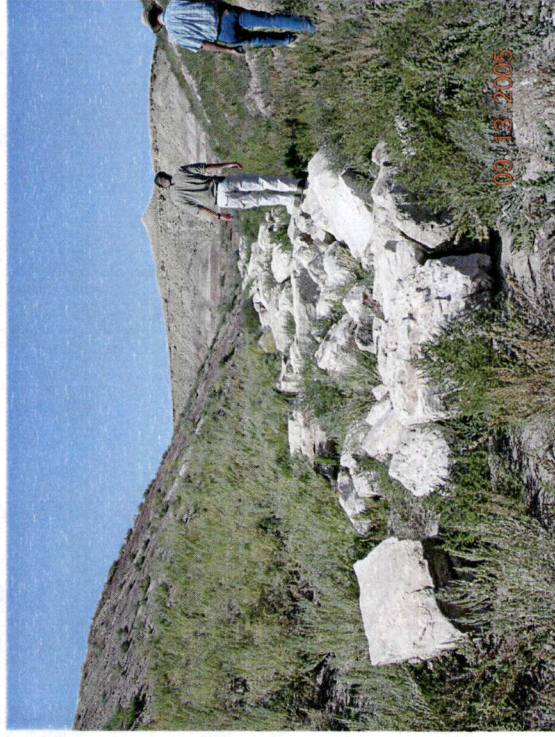
Photo 9. The channel coming out of the breached pond. Most of the vegetation is halogeton.
